## 14. NASA STUDIES ON EFFECT OF GROOVED RUNWAY OPERATIONS ON AIRCRAFT VIBRATIONS AND TIRE WEAR

By Thomas J. Yager

NASA Langley Research Center

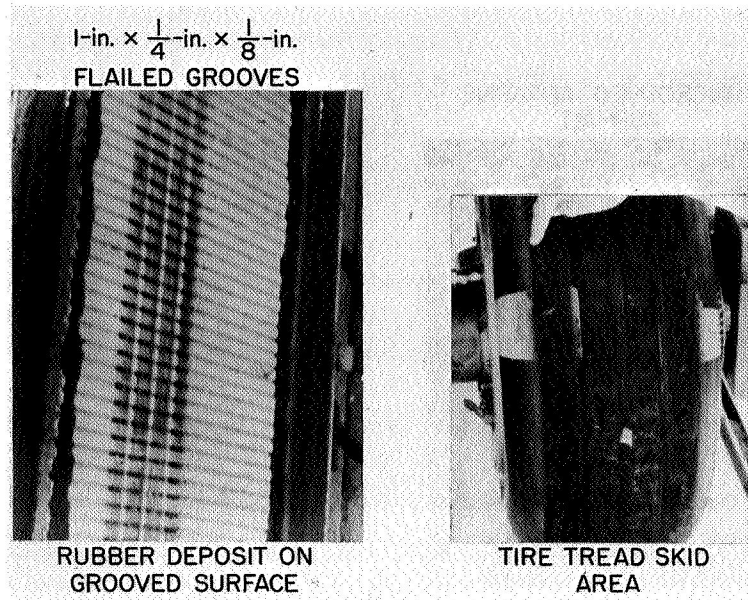
In an attempt to determine the effect of transverse pavement grooves on aircraft tire tread wear and cutting, tests with various types of aircraft tires were made at the landing-loads track. Figure 1 shows the results obtained with a 3-groove fabric-reinforced 30 × 11.5-14.5, type VIII, aircraft tire during a low-speed (4 knots) braking test run on the 1- × 1/4- × 1/8-inch transversely grooved test surface for a dry surface condition. The test tire was inflated to 210 lb/in<sup>2</sup> and the test was conducted at 0° yaw. As shown in the photographs of figure 1, tread rubber was deposited on the test surface but the tire tread did not receive any cuts or damage during this run from a free-rolling condition to a locked-wheel condition. Some tread wear, however, did occur at relatively high slip-ratio values. In contrast to the normal trend observed on smooth surface runways where the rubber deposits adhered to the surface, the tread rubber deposited in the dry surface grooves during locked-wheel braking was powdery or granular in form and could be easily brushed away.

Figure 1.- Condition of grooved surface and tire after braking test. 3-groove fabric-reinforced  $30 \times 11.5-14.5$ , type VIII, tire; inflation pressure, 210 lb/in<sup>2</sup>; dry surface; ground speed, 4 knots; 0° yaw.

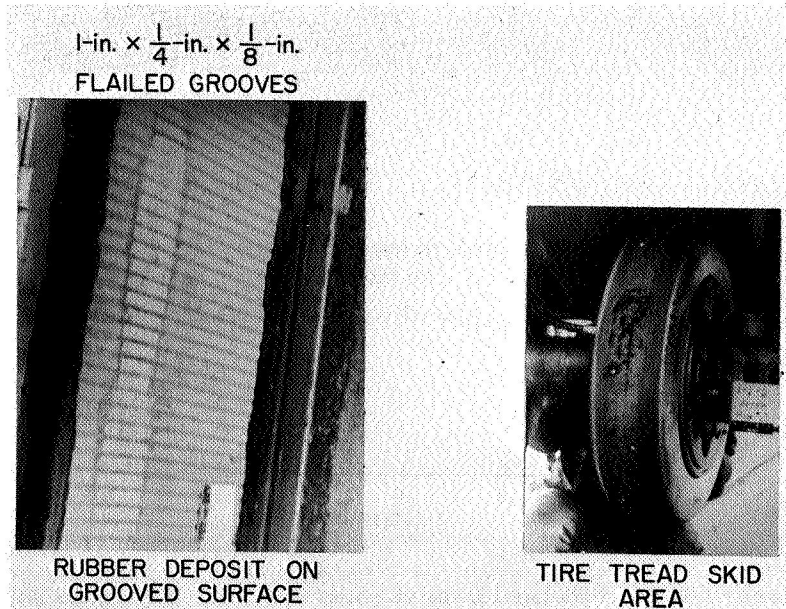
As indicated by the photographs of the tire skid area, some tire wear occurred for locked-wheel conditions on the 1- × 1/4- × 1/8-inch grooved surface, but on the ungrooved abrasive asphalt surface for the same test conditions, substantial damage to the tire tread occurred. Some of the tread cuts resulting from the braking run on the ungrooved surface were as deep as the tire cord. Considerable side force was developed by this test tire at 4° yaw during the run prior to the locked-wheel condition but no other tread wear or cutting occurred except for that shown in figures 2 and 3.

Figure 2.- Condition of grooved surface and tire after braking test. Fabric-reinforced rubber tread tire; inflation pressure, 400 lb/in<sup>2</sup>; damp surface; ground speed, 4 knots; 40° yaw.

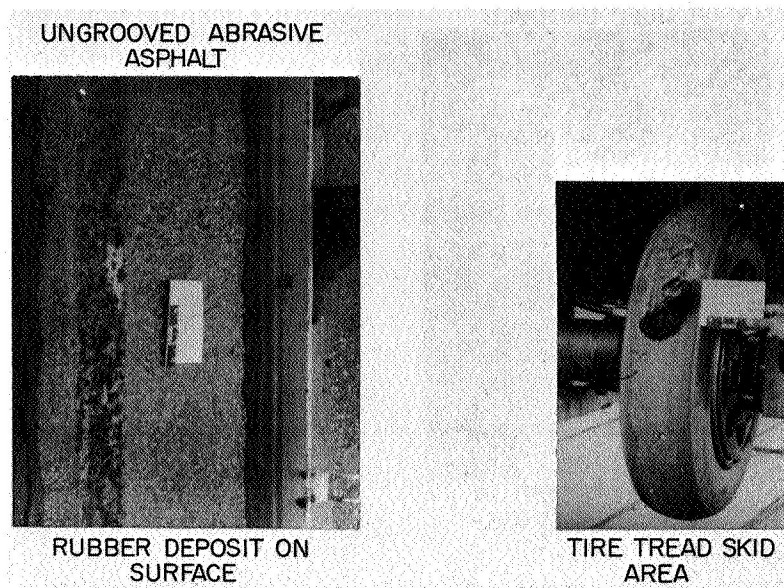
Figure 3.- Condition of ungrooved surface and tire after braking test. Fabric-reinforced rubber tread tire; inflation pressure, 400 lb/in<sup>2</sup>; damp surface; ground speed, 4 knots; 4° yaw.

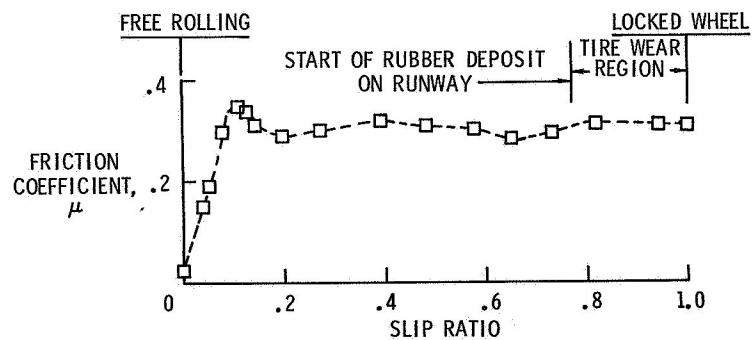
By using a new  $30 \times 11.5-14.5$ , type VIII, aircraft tire, a braking test run at 102 knots was made at the landing-loads track to evaluate further the effect of pavement grooves on tire tread wear. The test tire had a 3-groove fabric-reinforced rubber tread, and the variation in friction developed between the tire and the grooved pavement during braking is shown as a function of slip ratio in figure 4. The damp test surface was grooved  $1 \times 3/8 \times 1/4$  inch. Figure 5 shows the 5-foot-long rubber deposit from the tread on this grooved surface and the tire tread damage area resulting from the braking run. By measuring the length of the tread damage area and by calculating the rolling circumference and angular velocity of the tire, it was determined that the surface rubber deposit was initiated at a slip ratio of about 0.8. Prior to this point in the braking cycle, no significant tread wear occurred. The tire tread wear and the chevron-type cuts shown in figure 5 occurred between slip ratios of 0.8 and 1.0. Therefore, the results of this test indicate that to minimize tire tread wear and cutting, high slip-ratio values should be avoided during aircraft ground operations.

Figure 4.- F-4D aircraft tire during braking on grooved surface. 30 × 11.5-14.5, type VIII, tire; damp concrete; ground speed, 102 knots.

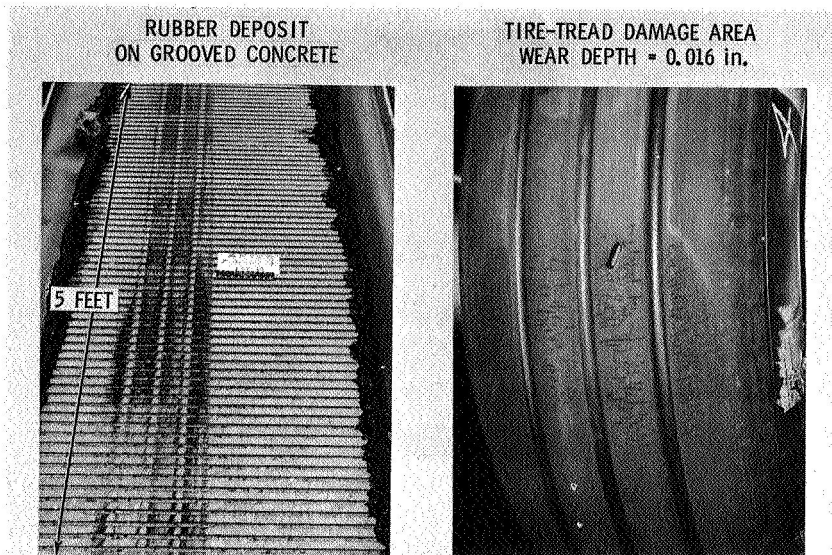
Figure 5.- Condition of test surface and tire after braking.

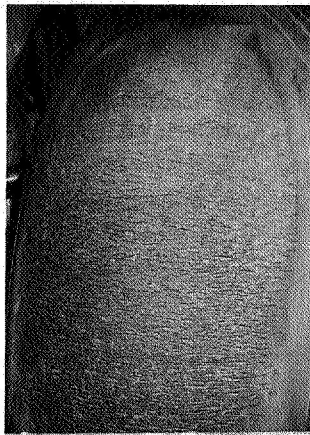
The condition of the tire tread as a result of the locked-wheel runs is shown in figure 7. The numerous, small chevron-type cuts in the all rubber tread of the smooth  $49 \times 17$ , type VII, test tire did not exceed 0.06 inch in depth. In subsequent test runs with this tire, the results indicated that these chevron-type cuts did not significantly impair the tire tread life.

Figure 7.- Condition of tire tread after locked-wheel runs.

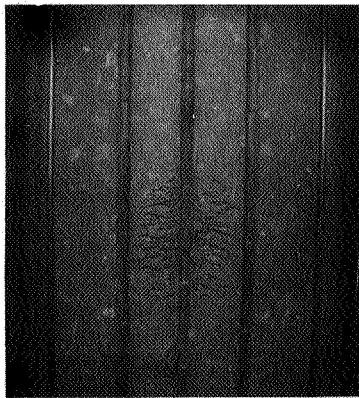
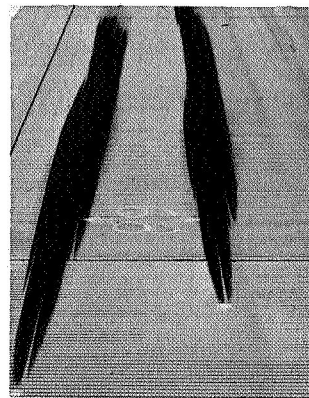
These chevron-type cuts in the tire tread were also observed during the tests of the 990 aircraft on the landing research runway. Figure 8 shows the condition of the tire and surface after a firm touchdown of the 990 aircraft on dry grooved concrete. The aircraft was equipped with new 5-groove all rubber tread main tires. Although only the right

main gear touchdown area is shown here, the left main gear touchdown area showed similar rubber deposits and all eight main gear tires had similar tread cut areas. In analyzing these results, the width of the rubber deposit on the runway at the point of initial touchdown equaled the width of the tread cut area on the main tires. Since the tires did not have any other cutting around the tread and the rubber deposit on the runway is shown to increase in width, it would indicate that the chevron-type cuts shown in figure 8 occurred only at initial touchdown when the tire was stationary. As soon as wheel spin-up started, the tire tread had no further cutting.

Figure 8.- Condition of grooved surface and tire tread after firm touchdown of 990 aircraft.  
Dry concrete; inflation pressure, 160 lb/in<sup>2</sup>.

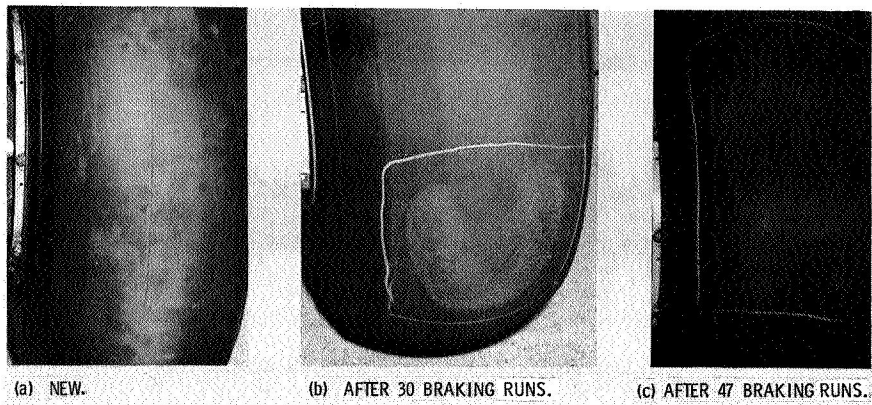
During the maximum antiskid braking tests of the F-4D aircraft, some tire tread wear was experienced but no chevron-type cutting was observed. However, no prolonged wheel lockups occurred during the braking tests of the F-4D, and the main tires of the F-4D had a 3-groove fabric-reinforced rubber tread. During the maximum braking tests of the 990 aircraft on wet and flooded surfaces, prolonged wheel lockups occurred on the ungrooved surfaces particularly with the smooth all rubber tread main tires. Because of the normal test run procedure of applying maximum antiskid braking through adjacent ungrooved and grooved tests surfaces, chevron-type cuts developed on the tire tread when the tire encountered the grooved surface at locked-wheel conditions. Some of the smooth tire tread cuts are shown in figure 9. No further cutting occurred during maximum braking test runs from a grooved to an adjacent ungrooved surface. Approximately 50 maximum antiskid braking test runs were made with the chevron cuts in the tire tread. Again the maximum measured depth of these cuts did not exceed 0.06 inch. As a result of further braking tests, these cuts increased in number but did not increase in depth.

Figure 9.- Effect of braking tests on smooth main tire tread of 990 aircraft,  $41 \times 15.0-18$ , type VIII, main tires; inflation pressure, 160 lb/in<sup>2</sup>.
